UNIPAK AVIATION LLC

Airbrake Jack P/N's AIR46520 & AIR46521 Mandatory Raytheon Service Bulletin 27-3589

Removal of Corrosion from Airbrake Jack Valve Body.

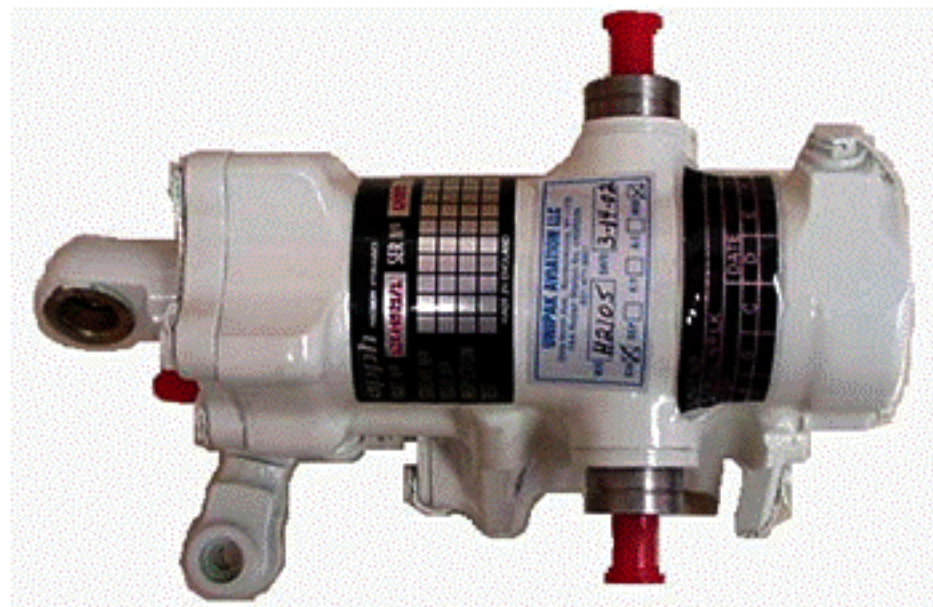
Some Airbrake Jacks have been experiencing sticking servo plungers caused by corrosion between the servo plunger and servo housing.
